ISD 192 Farmington Area Schools Boeckman Stormwater Retrofit

Project: 1,820 square feet of amended soil turf infiltration area provides water quality treatment for the stormwater runoff from approximately 6.1 acres of existing roof and parking lot area.

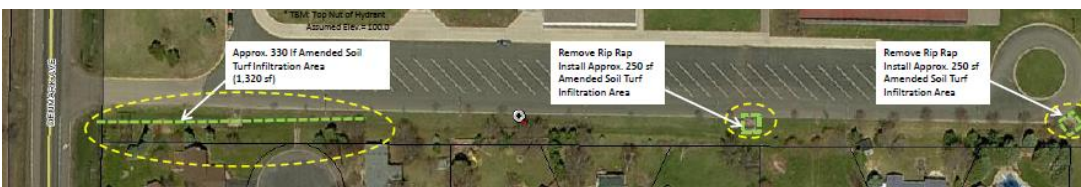
Approx. 330 lf Amended Soil Turf Infiltration Area (1,320 sf)

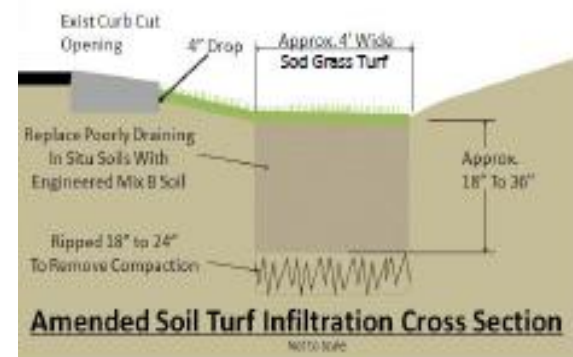
Remove Rip Rap Install Approx. 250 sf Amended Soil Turf Infiltration Area

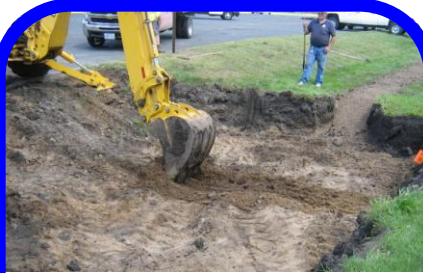
1,820 square feet of infiltration area was created by replacing 150 cubic yards of poorly drained soil with a 70% sand and 30% compost soil mixture.

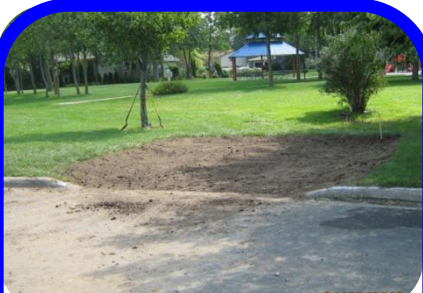
At three existing curb openings, poorly drained soils were replaced to create 250 square foot infiltration areas.

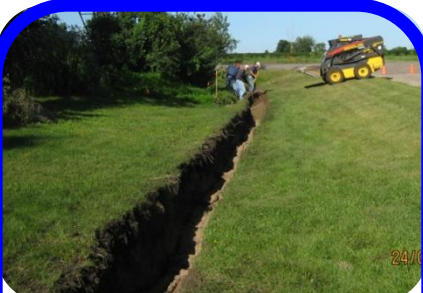
Soils were replaced in a 330 feet long trench to create 1,320 square feet of infiltration on the one side of the swale.

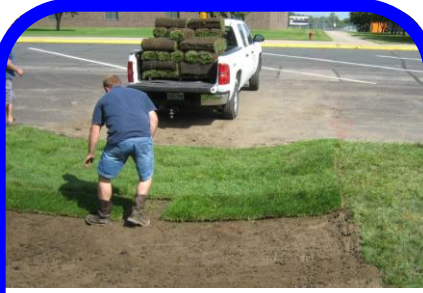
Turf sod installation was completed within backfill areas to avoid having exposed soils in the swale.

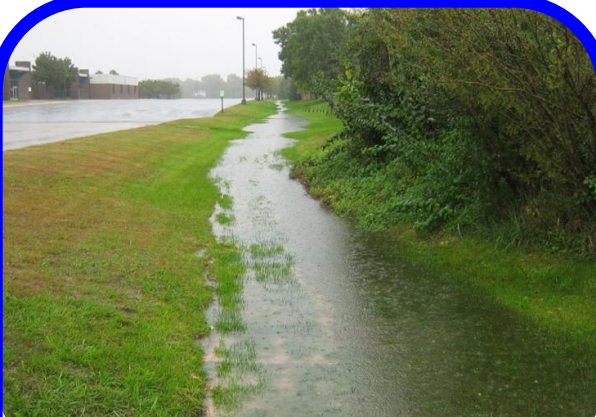
Amended soil turf Infiltration area during a rain event. Surface ponding completely infiltrated within six hours following the rain event.

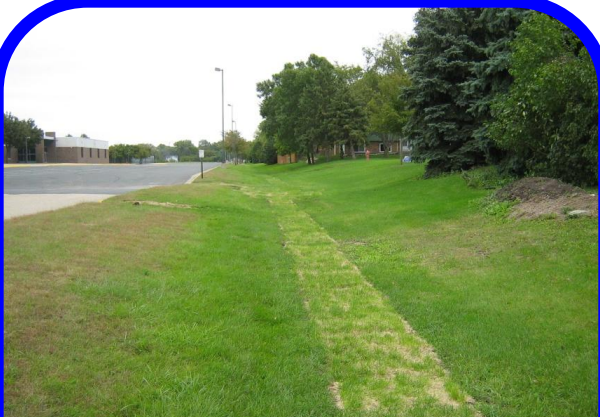
Mowed infiltration areas are integral to the surrounding landscaping. No special maintenance is required.
